### Characterisation of the VELO High Voltage System

Barinjaka Rakotomiaramanana<sup>1</sup>, Chris Parkes<sup>1</sup>, Lars Eklund <sup>1</sup>

LHCb Public Note, LHCb-2008-009

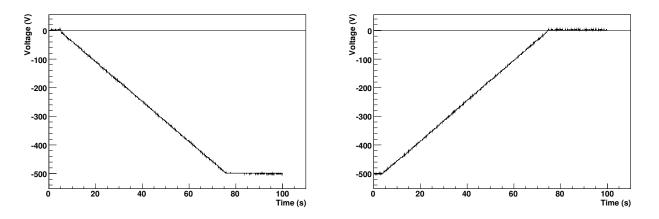
Figure 1: Voltage measured on an oscilloscope during ramping of channel 15 of the high voltage module with serial number 474185 07/2006. The performance when ramping from 0V to -500V (left) and from -500V to 0V (right) is shown.

The first test verifies that the full range of voltage can be applied to each channel of each high voltage module. Initially the voltage was ramped from 0V to -500V and then from -500V back to 0V. The control was performed through software and a ramping speed of 7V/s was used. The voltage produced by the high voltage module was measured as a function of time with an oscilloscope. Two plots were produced for each channel: one for ramping up and one for ramping down, see Figure 1. These two plots were produced for each channel of all 9 high voltage modules. No problems were observed.

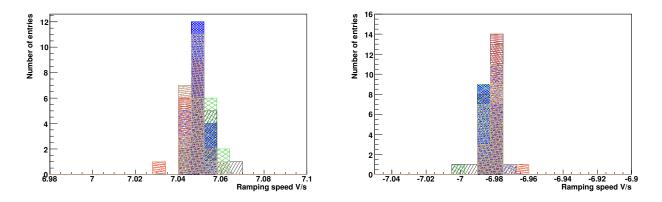
Figure 2: Variation of the ramping speeds measured on each individual module by applying voltage (left) from 0V to -500V and (right) from -500V to 0V. One colour represents the group of 16 channels of one high voltage module, all 9 modules are shown but are not clearly visible as the plots are superimposed.

Using the data from the previous test, the consistency of the ramping speeds in each channel of each module can be tested. Each power supply module has 16 channels. The gradient of ramping, up and down, is calculated for all 16 channels of each module. The nominal ramping speed set though the software is 7V/s. The results of this check are shown in Figure 2. The ramping speeds calculated during ramping up from 0V to 500V are slightly higher than the ramping speed set through software, while those for ramping down back to 0V are mostly slightly less than the ramping speed set through software. The variance of the ramping speeds from channels of different modules is larger than that inside a single modules. All channels of all modules performed acceptably and were within 1% of the set value.

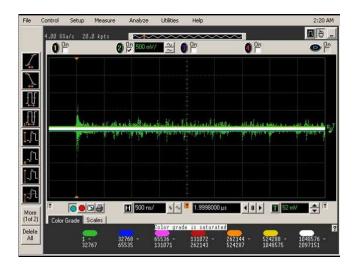
Figure 3: Oscilloscope trace showing a test for voltage spikes. The trace was taken in persistency mode for 12 hours with -140V applied. The voltage scale is 500mV/div. The time scale is 500ns/div.

- Voltage applied was -140 V.
- The oscilloscope was in persistency mode, AC coupling was used, and the trigger level was set at 52mV.
- The operation was performed for 12 hours.

Figure 3 shows that the biggest spike observed is around 500mV.

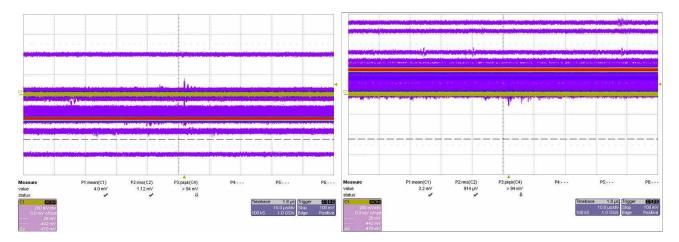
Figure 4: Oscilloscope traces showing a test for voltage spikes during ramping of the voltage. The trace was taken in persistency mode. A- (left) The voltage was ramped from 0V to -200V. B- (right) The voltage was ramped from -200V to 0V. The voltage scale is 200 mV/div. The time scale is  $10 \mu \text{s/div}$ .

Figure 4A shows the oscilloscope trace when the voltage ramps up from 0V to -200V and Figure 4B when it ramps down from -200V to 0V in persistency mode. The two figures show that there are no obvious significant spikes during ramping.

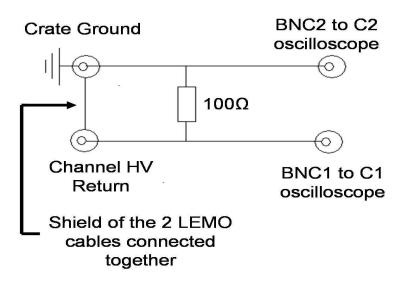
Figure 6: Schematic of the common mode noise measurement setup.

A test was performed to measure the noise level produced by the potential difference between the ground of the power supply crate and the HV return of the channel. Figure 6 shows the schematic of the setup used to measure this common mode noise.

The channel HV return was connected directly to channel 1 of the oscilloscope and the ground of the crate to channel 2 of the same oscilloscope. The noise was displayed and measured on the oscilloscope by subtracting channel 2 from channel 1. The measurement on the oscilloscope was made in the following settings:

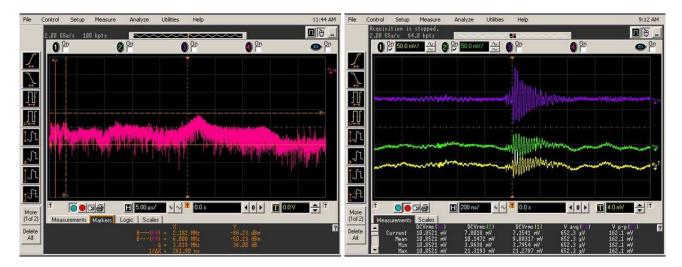
Figure 7: Oscilloscope traces of the common mode noise measurement. A- (left) Fast Fourier Transform of the common mode noise. The frequency domain was from 0Hz to 100MHz. B- (right) The oscilloscope trace which shows the non Gaussian component of the noise. The time scale was 200 ns/div and voltage scale 4mV/div.

Figure 7A is an oscilloscope screen image showing an example noise distribution. The following results were obtained:

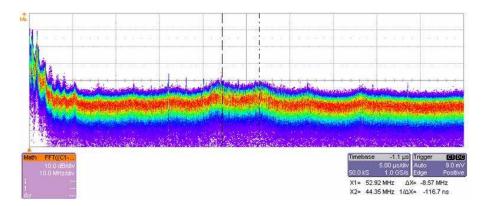
Figure 8: Oscilloscope trace showing the noise measured at the detector cable output between HV guard and ground. The time scale was  $5\mu s/division$ . The frequency domain was from 0Hz to 100MHz.

Figure 8 is a screen image from the oscilloscope. The following results were obtained:

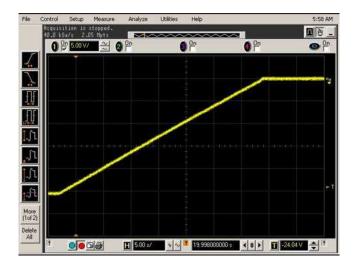
Figure 11: Oscilloscope trace shows the output voltage of the module when a power cut occurs. The time scale is 5s/division.

The voltage of -500V is maintained on the channels for approximately 10s, as seen in Figure 11A. It then takes approximately 40s to ramp down from -500V to 0V. After a further 10s the modules switch off completely. This behaviour of the UPS system provides a safer operation of the system than the sudden cut of voltage that would otherwise occur.

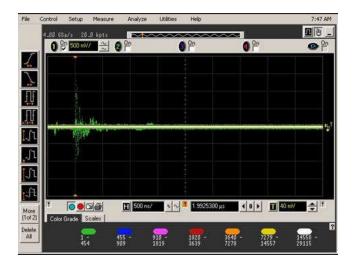
Figure 12: Oscilloscope trace of the output voltage during a brown-out when it is in persistency mode. The voltage scale is 500 mV/division. The time scale is 500 ns/division.

The main power to the crate was switched off and on again to simulate a brown-out of short duration, for example 2s. Figure 12 shows that a brown-out causes a spike in the voltage observed, but that the highest spike observed was approximately 1V.

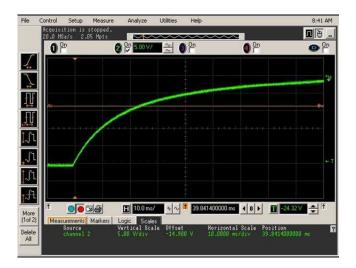
Figure 14: Oscilloscope trace of the output voltage when the interlock signals were removed. The time scale is 10ms/division.

The interlock signals were then fired. Figure 14 shows that it takes approximately 90ms for the module to ramp from -500V to 0V when the HV inhibit is fired.

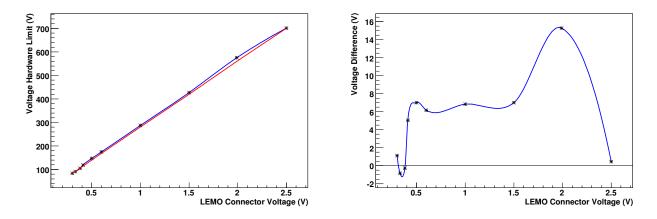
Figure 15: A- (left) Hardware voltage limits as a function of voltages measured from the LEMO connector. B- (right) Discrepancy between the measured hardware voltage limits and linear behaviour for the voltages measured from the LEMO connector.

The performance of the voltage limit was tested over the full voltage range of the power supply and was found to function correctly.

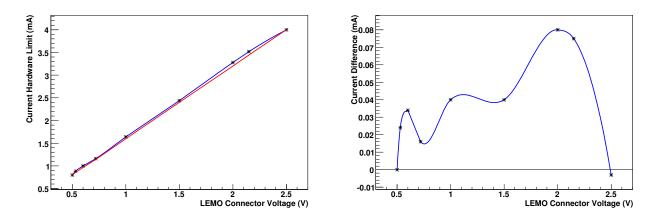
Figure 16: A- (left) Hardware current limits as a function of voltages measured from the LEMO connector. B- (right) Discrepancy between the measured hardware current limits and linear behaviour for the voltages measured from the LEMO connector.

Figure 16A shows the measured current limits as a function of them measured voltage on the Imax LEMO connector as the blue line. The pink line in Figure 16A is obtained by assuming a linear relationship where 2.5V corresponds to 4mA output on the power supply. Figure 16B shows the discrepancy between from the linear behaviour is small.

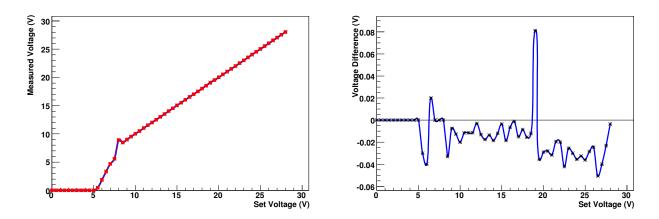
Figure 17: Comparison of the requested and measured voltages at low voltages. A- (left) Voltage measured as a function of the set voltage. The blue points, largely obscured, are for PVSS software measurements and the pink points are for DVM measurements. B- (right) Difference between the PVSS and DVM measurements as a function of the requested voltage. These results are for channel 5 of the module with serial number: 474189 07/2006.

shows the result obtained when setting voltages from 0V to 28V via the PVSS software in steps of 0.5V. The PVSS measurements (blue points) and the DVM measurements (pink points) are all averages over several measurements. Both measurements are consistent (indeed the blue points are largely obscured by the pink points on this scale) and their differences are presented in Figure 17B.

It is clear from Figure 17 that the behaviour above 9V is as expected, the measured voltage in software and through the DVM both agree we the voltage that has been requested. This confirms the normal operating behaviour that was reported in section 3.

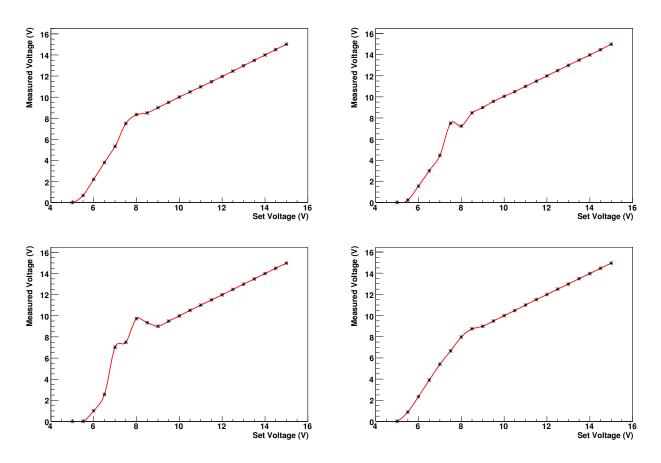
Figure 18: Measured voltage as a function of set voltage for low voltages. A- (top left) channel 1 of the module with SN: 474195 07/2006 B- (top right) channel 10 of the module with SN: 474193 07/2006 C- (bottom left) channel 15 of the module with SN: 474191 07/2006 D- (bottom right) channel 2 of the module with SN: 474191 07/2006

Note also that the behaviour of all channels on a single module is not the same, see 18C and D. It was not clear that the variation in behaviour between channels on different modules (e.g. 18A, B, C) is any larger than between channels on the same module.

The difference between the values set and the voltage measured in this low voltage region are thought to be due to the noise of the ADC and of the voltage dividers in the power supply module in this region. In discussion with the power supply company, the modules were claimed to typically be calibrated above 1% of the maximum voltage, i.e. above 7V. However, the company has seen problems with the calibration and suggest that the true calibration may be only achieved above 1.5% (11V) to 2% (14V). From the tests reported here, we advise only using the system above 10V.
